EXHIBITS TO ACCOMPANY PLAINTIFFS' MOTION IN LIMINE AND TO PRECLUDE  
EXPERT TESTIMONY

**RE.: Claim Number: 20-5229-622  
GMA Case Number: 3823**

May 31, 2000

In regard to the above claim, I have completed a review and evaluation of the following information and materials:

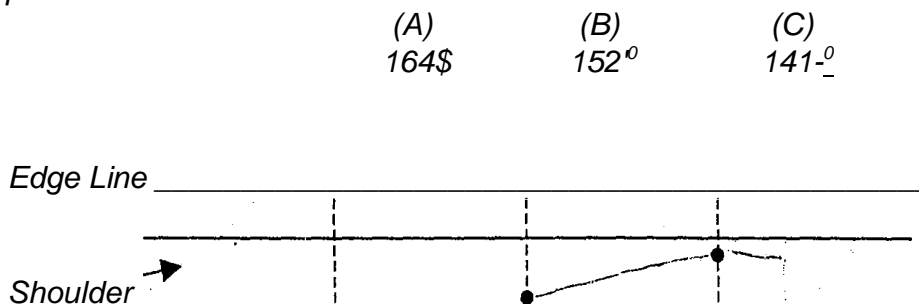
orange paint marks \*

Six orange paint marks were observed on the edge line and shoulder. The following diagram shows the longitudinal position of the paint marks with respect to the west edge of the Interstate 81 overpass:

The distance between paint marks B & C is 11 feet. Specifications indicate the Ford's wheelbase to be 11 feet, 1 inch. Therefore, these marks are consistent with the rest position of the truck's wheels. In the area of these paint marks, the width of the paved shoulder was measured to be 9½ feet. The published maximum width of the Ford truck

*is 6 feet, 7 inches. The paint mark at point B is laterally positioned on the south edge of the white edgeline. Although the Ford's left rear tire was removed from the vehicle at the time of impact, the position of the associated paint mark appears to be consistent with the location of the Ford in the NBC News videotape footage.*

*Seven additional paint marks were observed along a 13-foot section of the paved shoulder - 42 to 55 feet from the Interstate 81 overpass. The location of these paint markings appear consistent with the rest position of the pedestrian as indicated in the police report diagram.*
